Instruction for upgrading FW of XR series receiver

---V2.0(2019.10.29)

Latest firmware version: V2.0 (as of 2019.10.29)

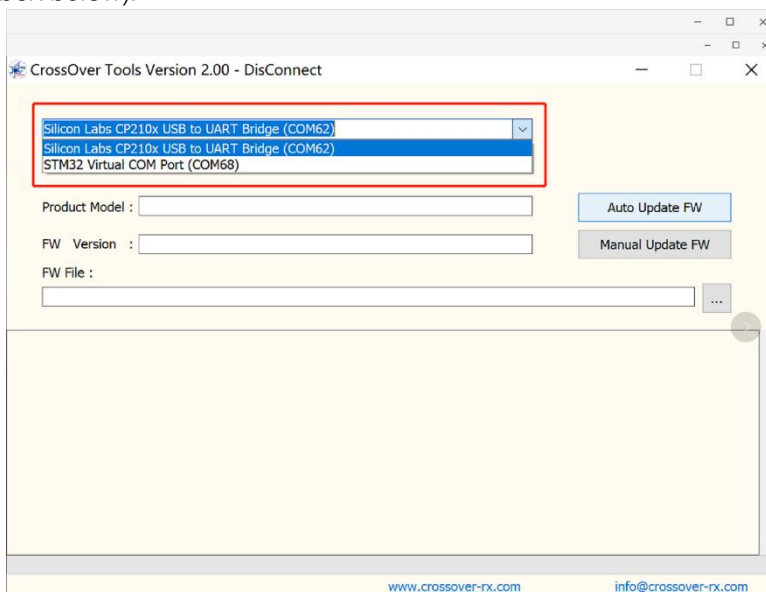
and select the correct serial port (as shown in the red box below):

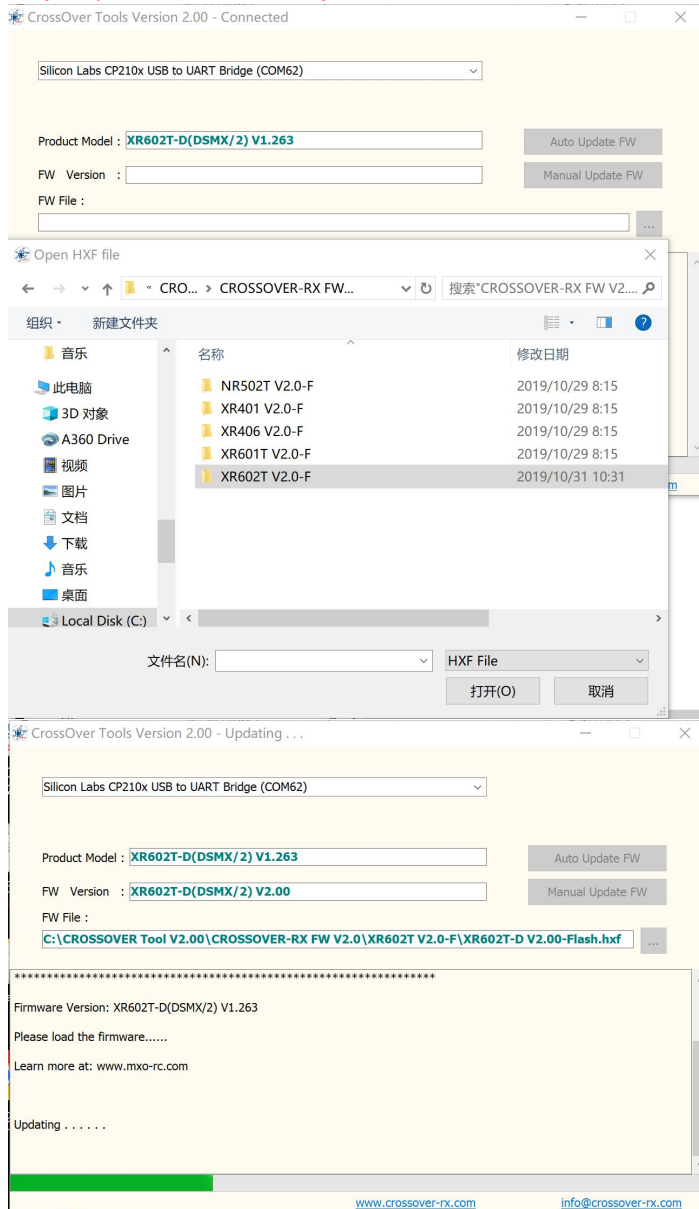
- 6) After clicking "Auto Update FW" on the GUI, the RX version number will appear on the GUI (please check the connection if NOT shows the RX version), and the firmware selection interface will appear (select the path where the firmware is located) as shown in the following image. Choose your receiver family after entering the firmware packages , double-click the firmware corresponding to your receiver after entering (if the firmware does not match your receiver GUI will prompt, point "OK" after reselecting the firmware).
 (Note: please carefully determine which series your receiver is: XR400,601T or 602T--this is very important, otherwise your receiver will become an useless brick!!!)

The GUI will then automatically run the firmware upgrade and receiver will enter normal operation mode after the upgrade is complete.
 (Note:The LED light will flash if firmware is inconsistent with hardware,then you have to upgrade it again from the start).

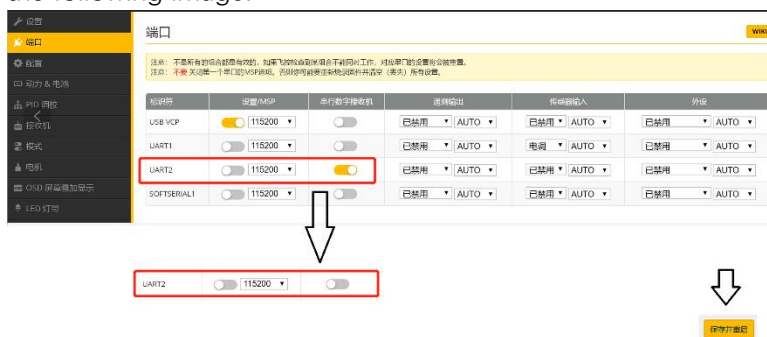
- 3) Connect the flight control to the computer via USB cable (press the BIND switch on receiver before power on, otherwise receiver cannot enter BOOT mode, release the BIND switch after power on--- this operation is to manually let RX into BOOT mode), Start BetaFlight and set up the UART interface used above, and then click the Save and Restart button, as shown in the following image:

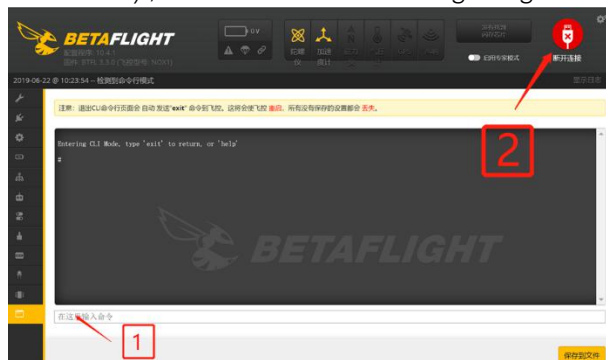
- 4) After the flight control restart, re-enter the BetaFlight interface and then go to the CLI interface;
- 5) Input the " **serialpassthrough 1 57600**" (where '1' is the UART ID; remember, UART 3 is actually ID 2, UART 2 would be 1, and UART 1 would be 0) instruction at "1" in the figure below, and point the "2" below (Note: Do not disconnect the USB and the flight control connection) , as shown in the following image:

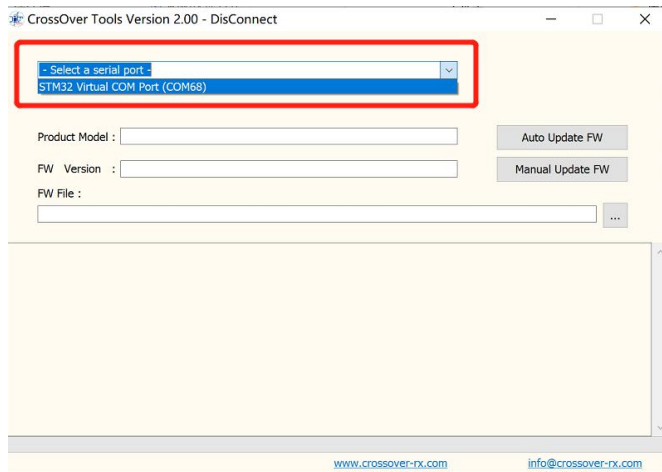
- 6) Start CROSSOVER Tool V2.00

and select the correct serial port;

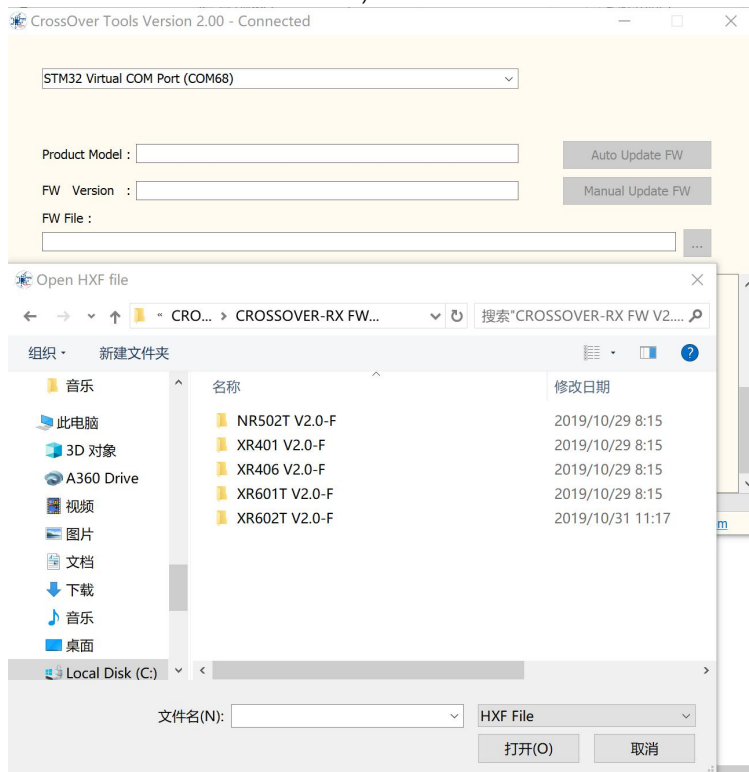
- 7) Click "**Manual Update FW**" on the GUI and the firmware selection interface(select the path where the firmware is located) will be shown as follows :

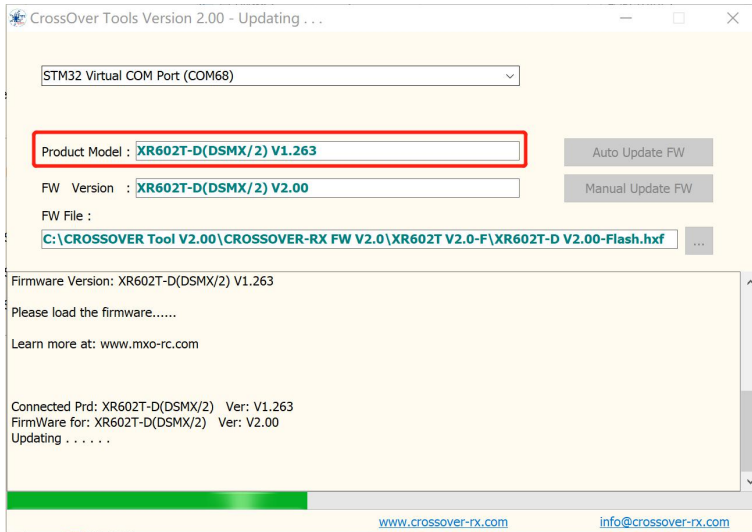
Choose your receiver family after entering the firmware packages, double-click the firmware corresponding to your receiver after entering (if the firmware does not match your receiver GUI will prompt, point "OK" after reselecting the firmware), at which point the RX version number is displayed on the GUI (if no RX version number is displayed, please check the connection and flight control settings), as shown in the following image:

(Note: please carefully determine which series your receiver is: XR400,601T or 602T--this is very important, otherwise your receiver will become an useless brick!!!)

The GUI will then automatically run the firmware upgrade and receiver will enter normal operation mode after the upgrade is complete.
